1947 Rover P2 16 HP; on show at 2012 Weekend Witness/VSCC Cars in the Park Cedric Macdonald

Getting by with a little help from one's friends.

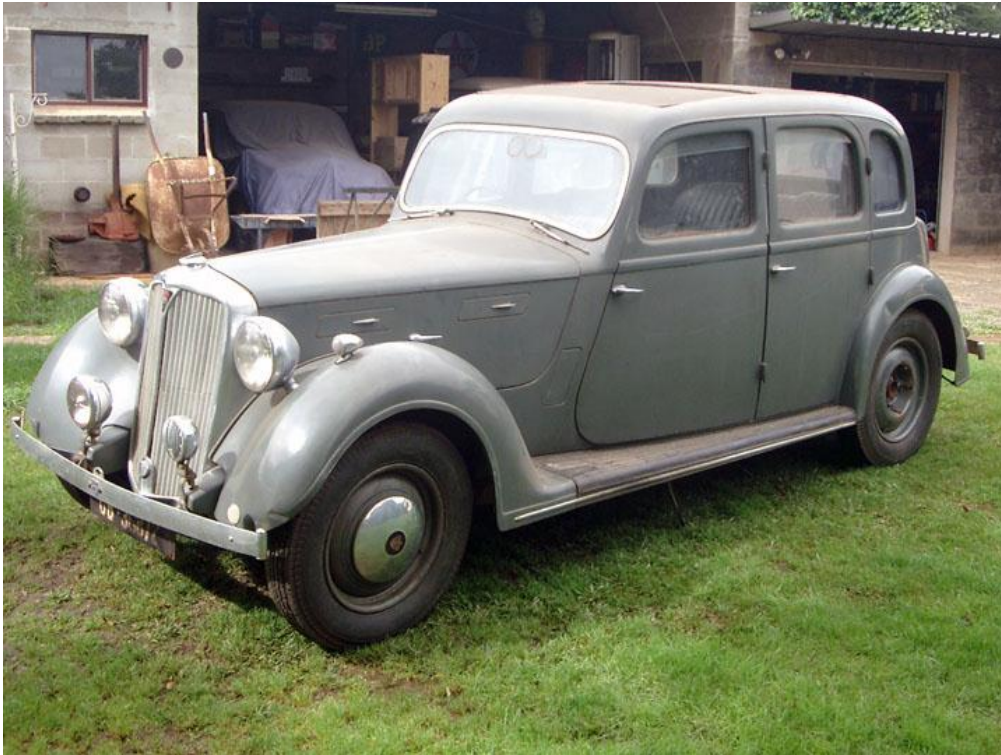
Basically complete, but a long way to go. Photograph: Rob North

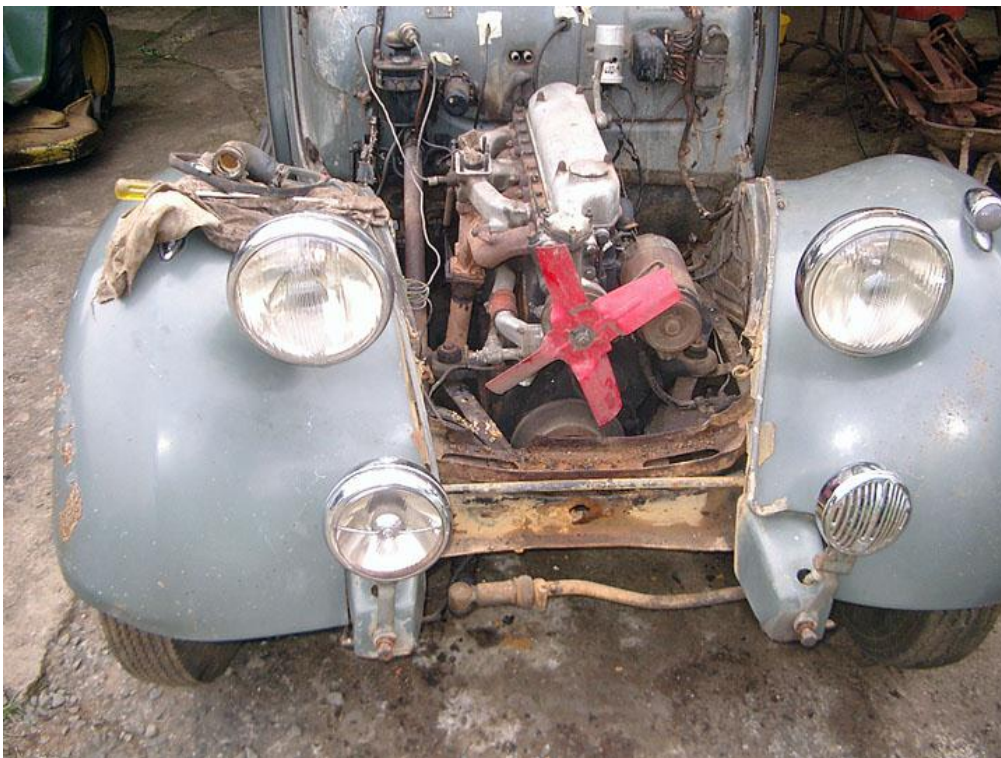
...or perhaps looking not so good? Photograph: Rob North

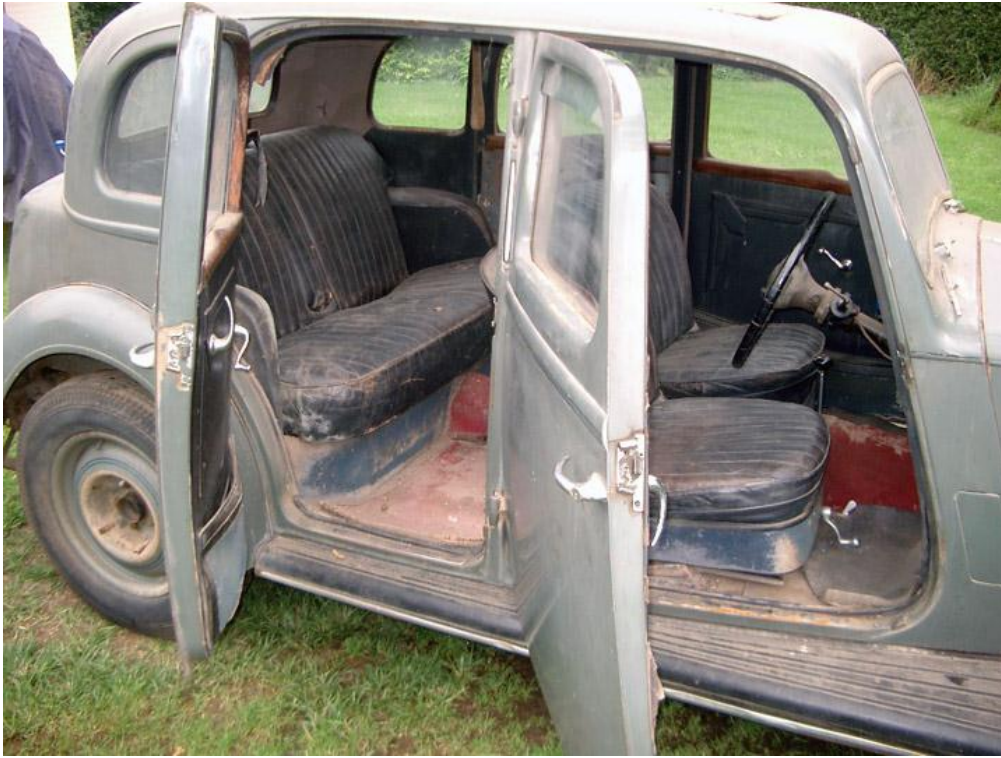
The interior needed to be stripped and redone. Photograph: Rob North

While the team set about stripping, straightening and repainting the riveted ladder frame chassis, the body and seats were sent out to specialists for refurbishment in its new colour scheme of two-tone blue-grey with blue upholstery. Then followed cutting and remaking of rotted wooden floor panels and sunroof framework. They refurbished door panels, carpeting and headlining, and stripped and re-varnished the decorative wooden trim on doors and dash. Sun visors, windscreen hardware and dozens of other items needed attention, so the team cleaned, resurfaced and repaired those as well.

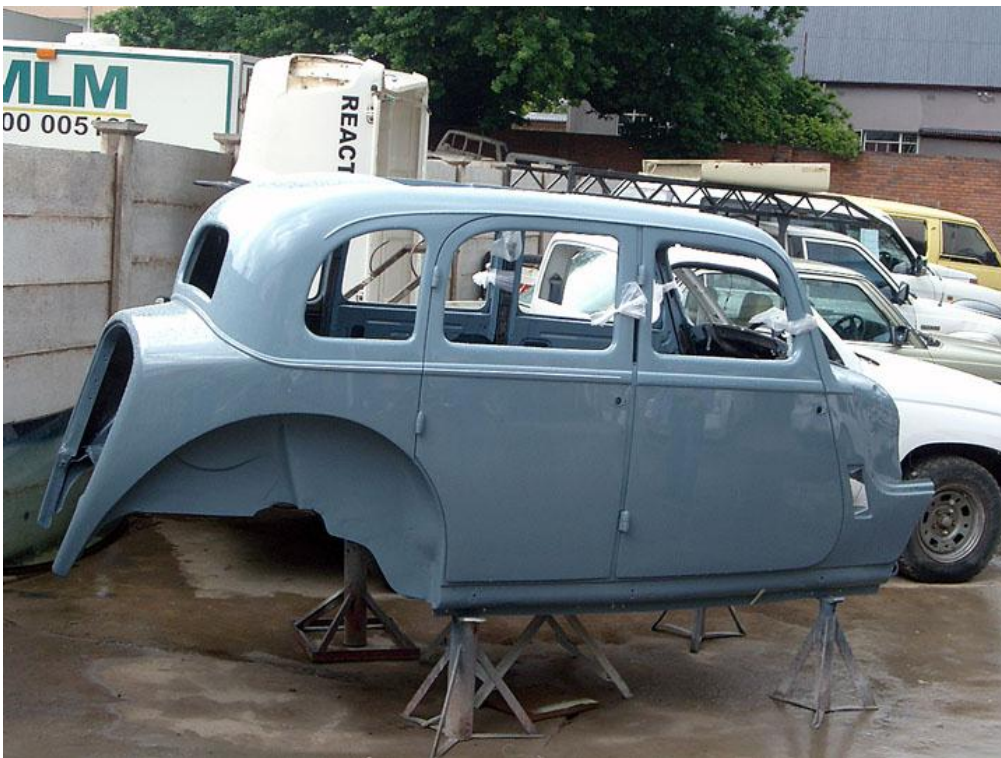
With the body back from the panel beaters. Photograph: Rob North

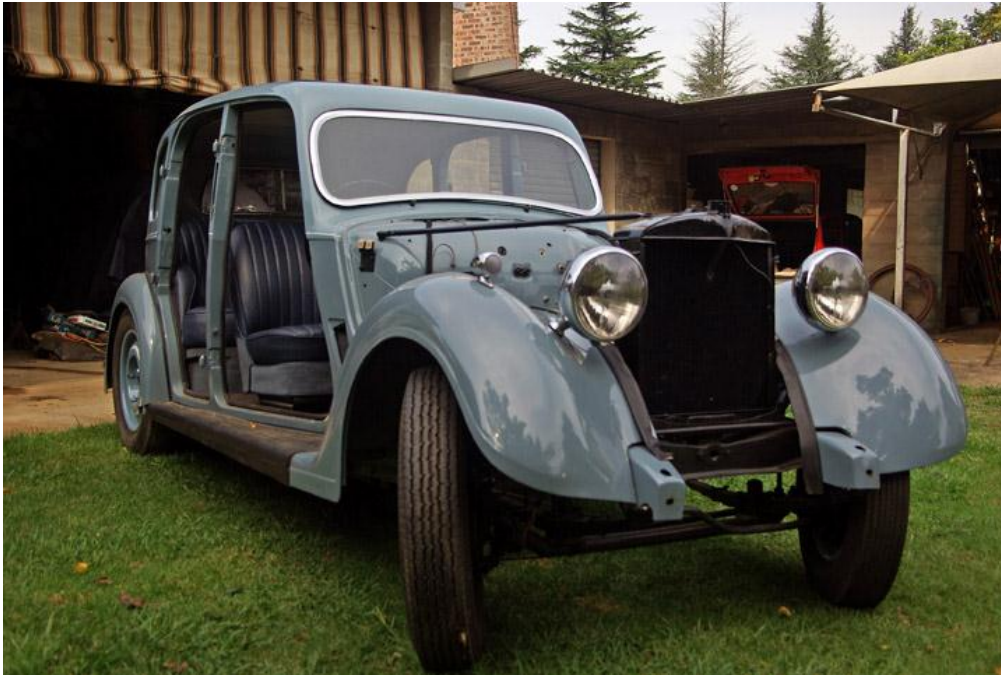
Reassembly could begin. Photograph: Gordon Hall

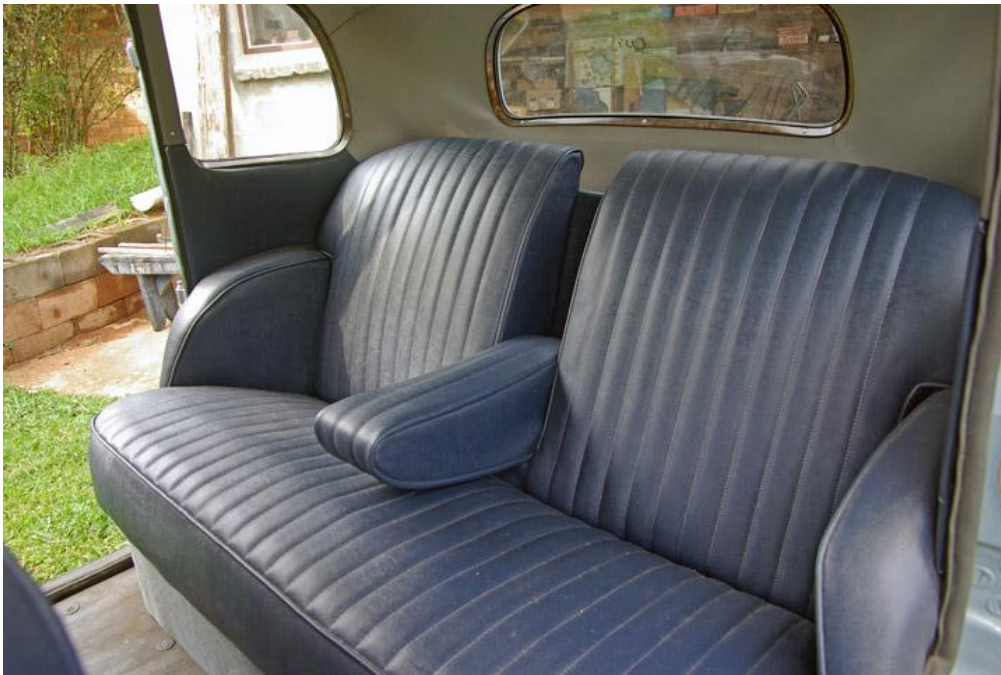
The seats were reupholstered by a local specialist. Photograph: Gordon Hall

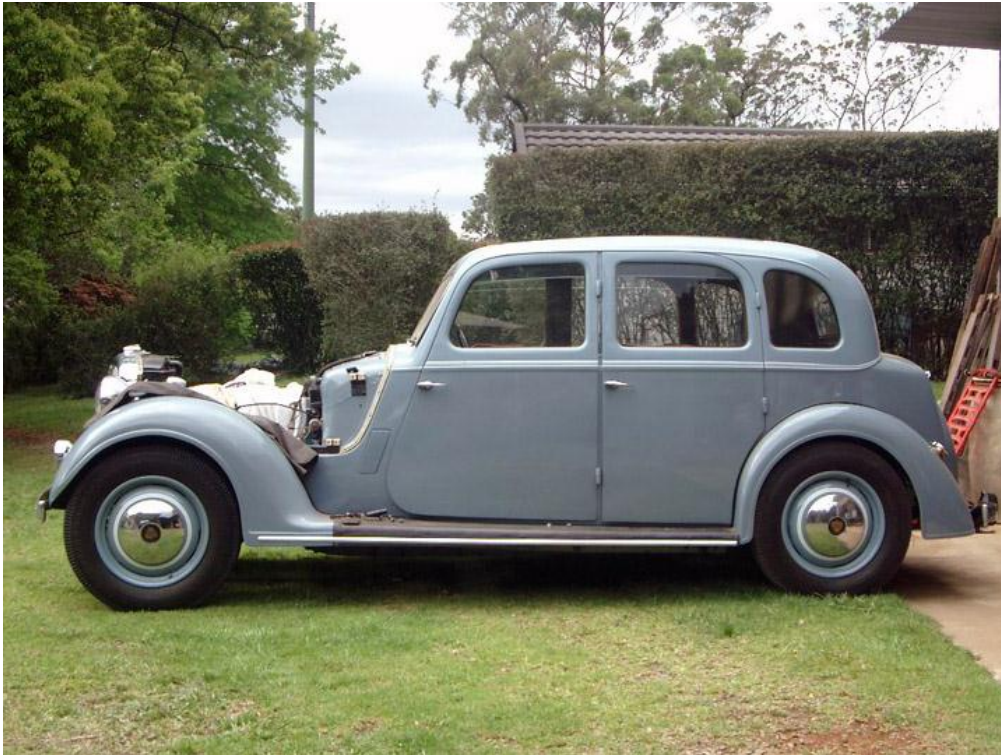
Just a new gearbox cover, reset the springs (again) and a couple of small details to go... Photograph: Rob North

The next is to sort out was an "S" licence so we could use it on the road to try out the mechanical brakes – adjustment of all the rods was new to me! The main work that was still to be done was the cover of the gearbox. The original was a rubber tunnel and completely perished. I made up a metal copy which had to be more exact in dimensions than the rubber one.

We had a lot of hassle with the rear springs. Being an underslung chassis at this point, makes setting requirements more exacting. We had them reset three times and still the rear end appeared low without any passenger load. We also needed to drive it a bit to get them to possibly settle. We had no reference to ride height dimensions."
